**Universal Underwriters Insurance Company
as subrogee of King Chrysler Jeep Dodge LLC
v. Dedicated Logistics, Inc., et al.
v. Pennsylvania Power Company**

Date of accident: 05/19/11

EXPERT REPORT

TransCon CSI File No: 13-003

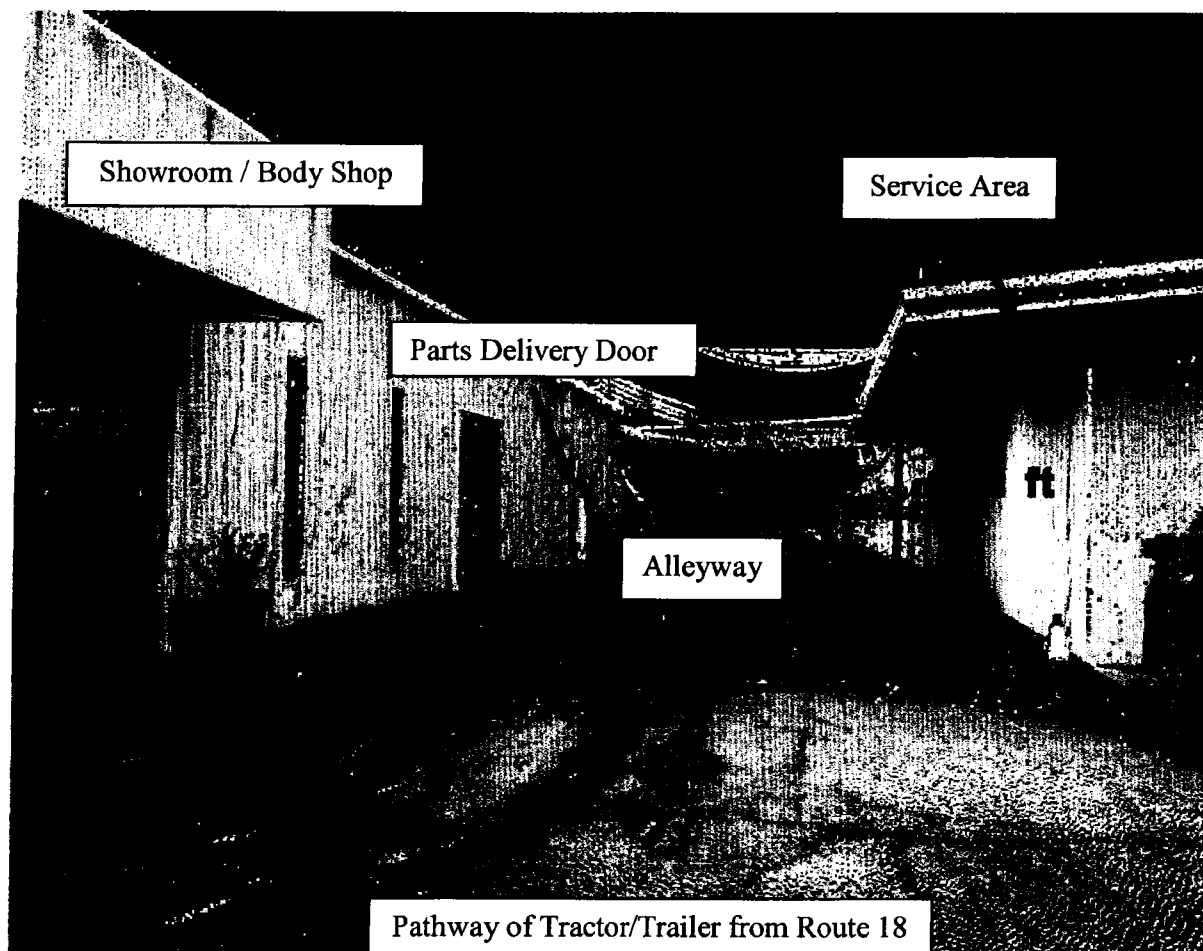
Figure 2 (below) is the parking lot view (facing west) coming from Route 18 and entering the alleyway.

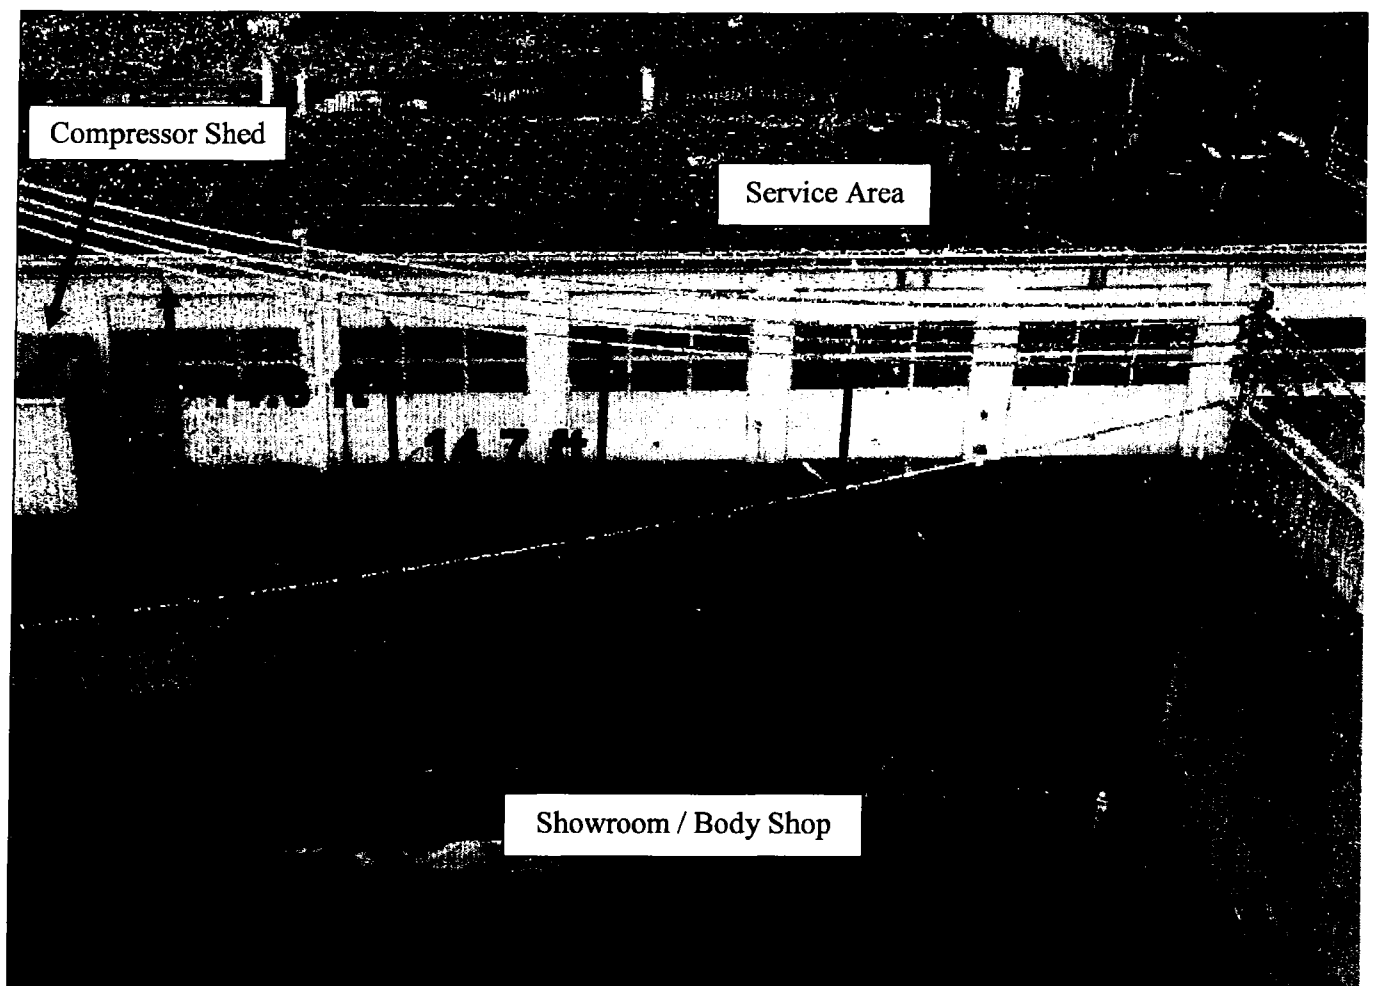
Figure 4 (below) is a view (facing north) of the Service Area just prior to the compressor shed.

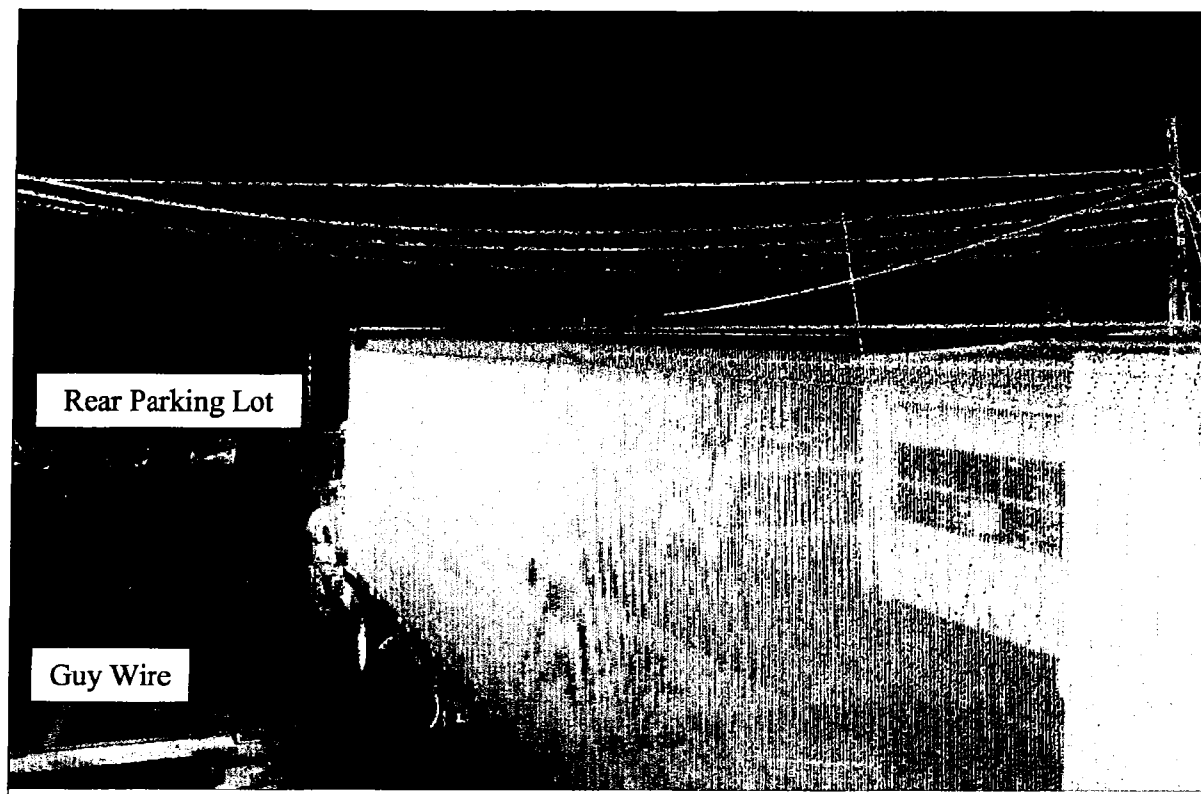
Figure 6 (below) is a view, facing west, of the showroom/body shop side of the alleyway depicting an exemplar tractor and trailer below the power lines adjacent to the guy wire at the entrance of the rear parking lot.

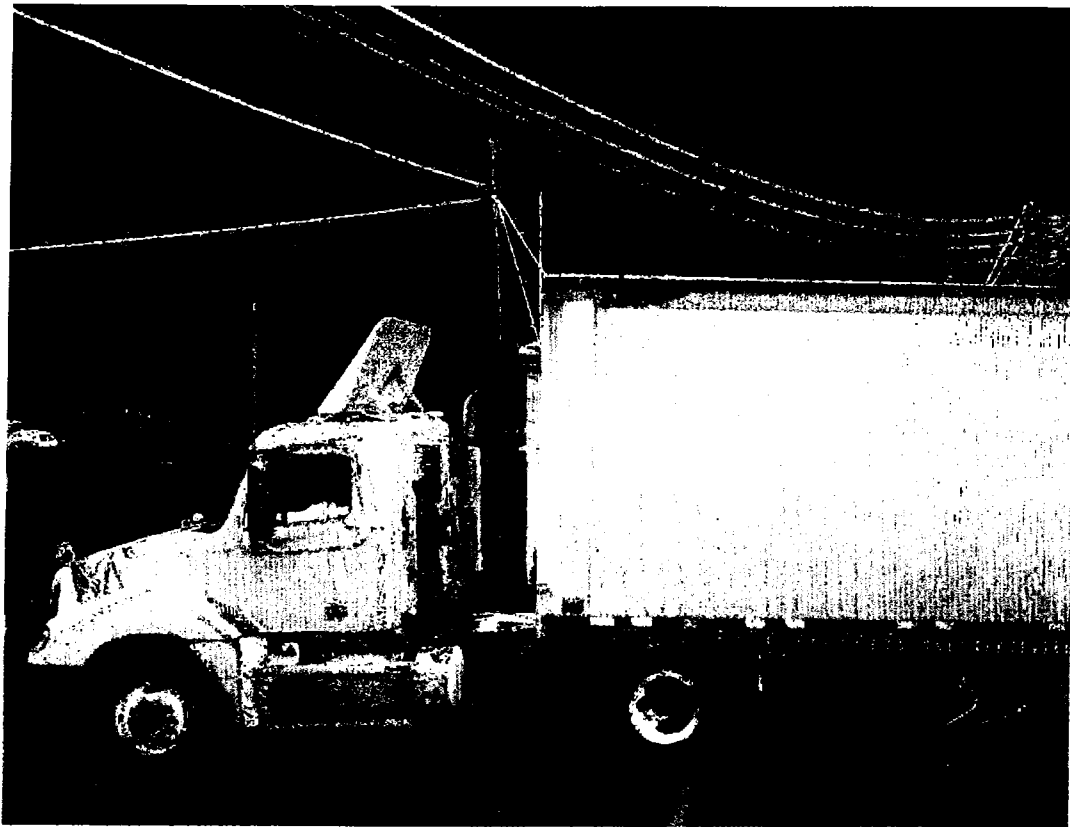
Figure 7 (below) is a view, facing north, of the showroom/body shop side of the alleyway depicting an exemplar tractor and trailer below the power lines adjacent to the guy wire at the entrance of the rear parking lot.

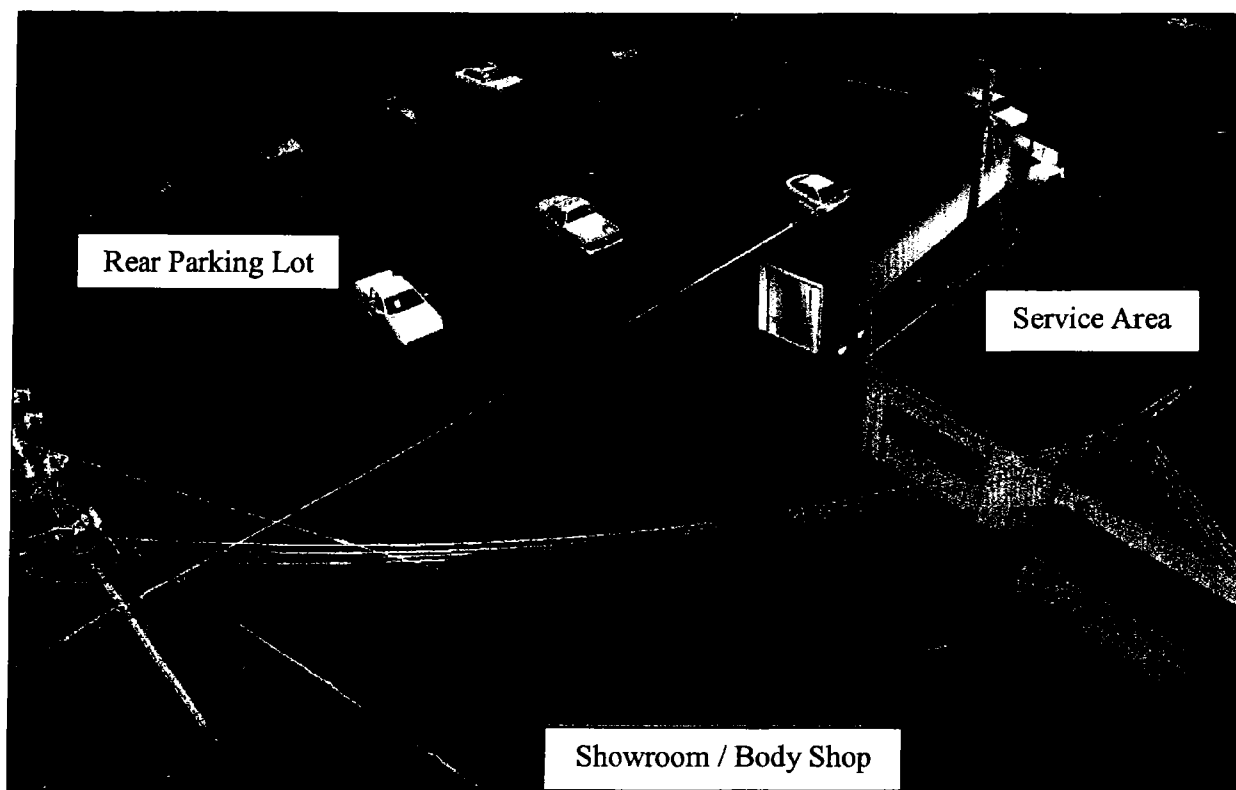
Figure 15

(Elevated view facing northwest, as the tractor/trailer is proceeding north in the parking lot.)

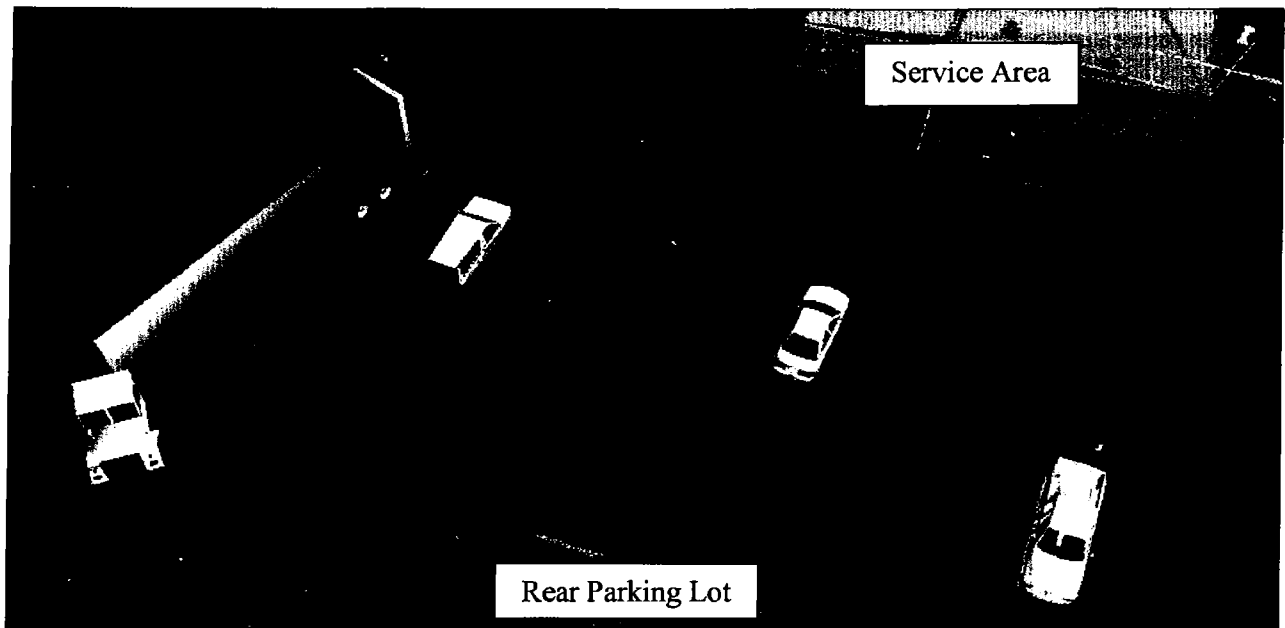
Figure 17

(Elevated view from the rear parking lot facing northeast, as the tractor/trailer is turning to proceed to the south end of the lot.)

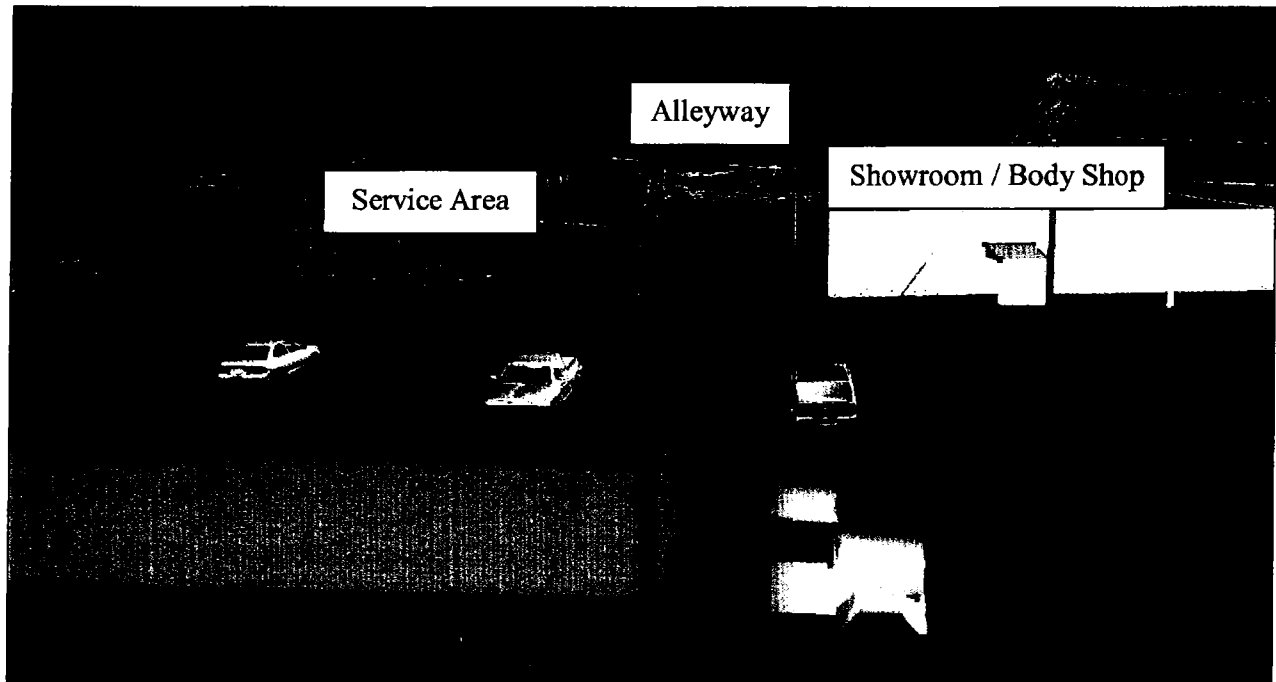
Figure 18

(View from the rear parking lot facing east, as the tractor/trailer is proceeding to the south end of the parking lot.)

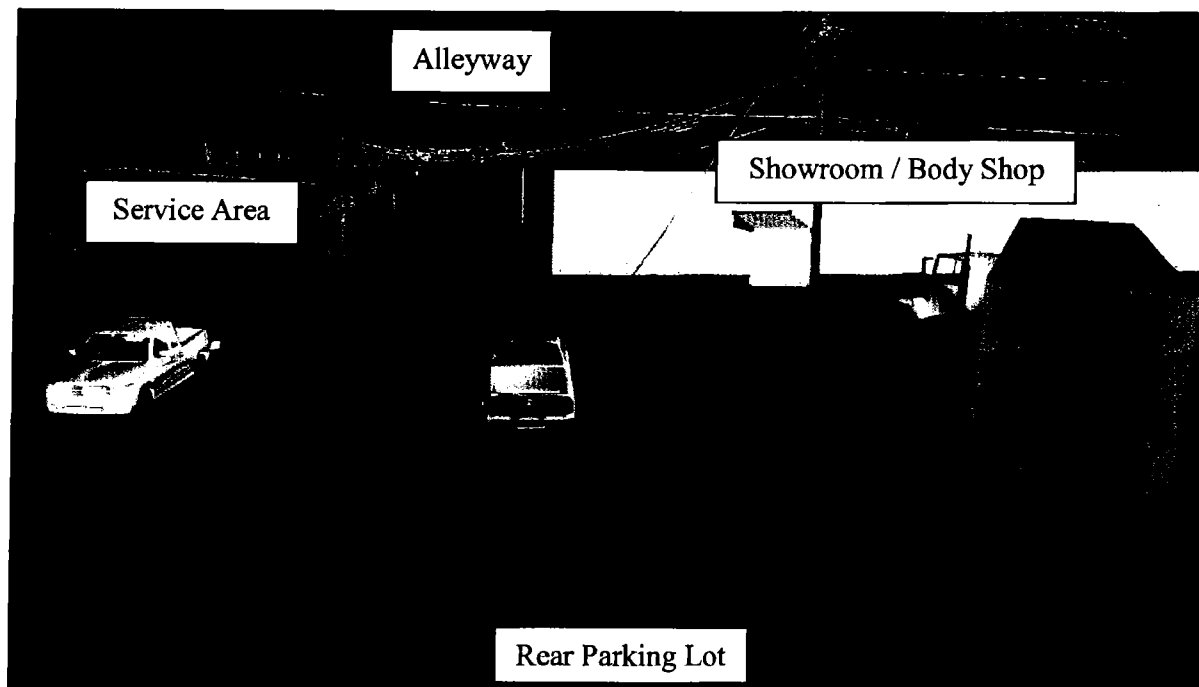
Figure 19

(View from the rear parking lot facing east, as the tractor/trailer is making a left turn to proceed toward the alleyway. At this position, Mr. Harris loses sight of the right side of his trailer).

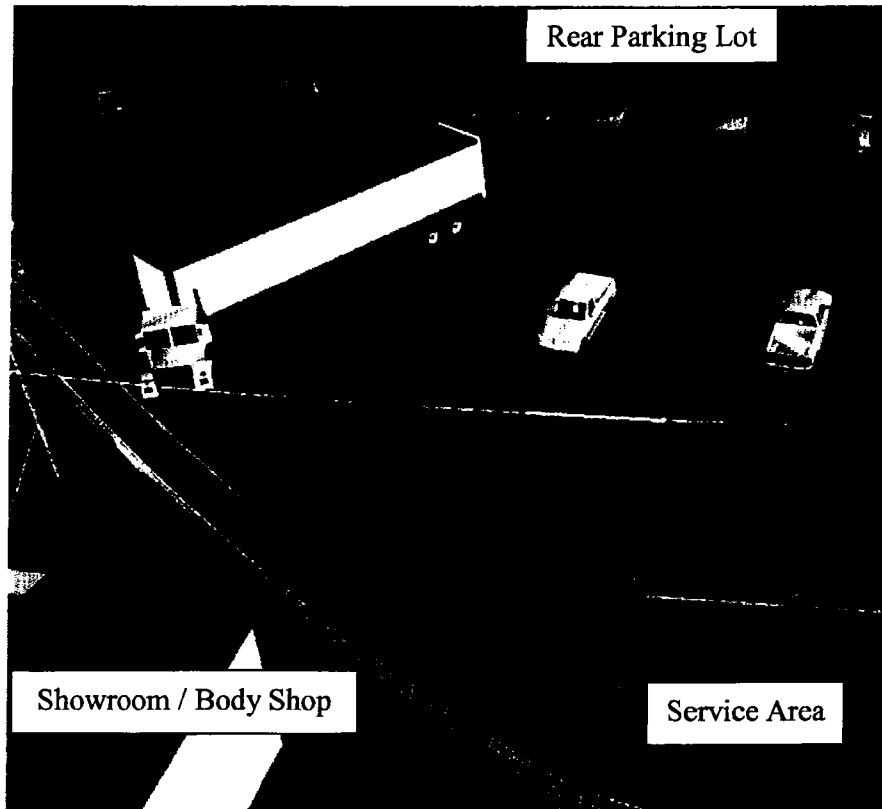
Figure 20

(Elevated view from the rear parking lot facing southwest, as the tractor/trailer is making a left turn to proceed toward the alleyway. At this position, Mr. Harris loses sight of the right side of his trailer).

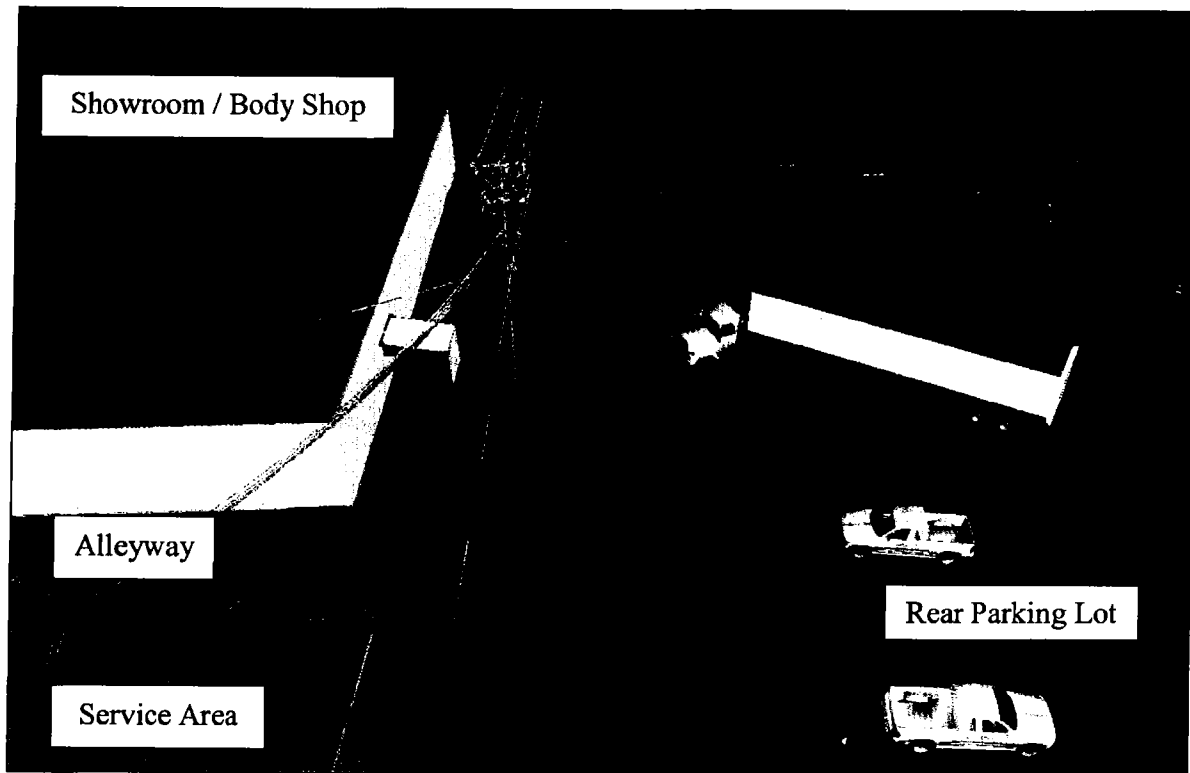
Figure 21

(Elevated view from the rear parking lot, facing south, as the tractor/trailer is making a left turn to proceed toward the alleyway. At this position, Mr. Harris loses sight of the right side of his trailer).

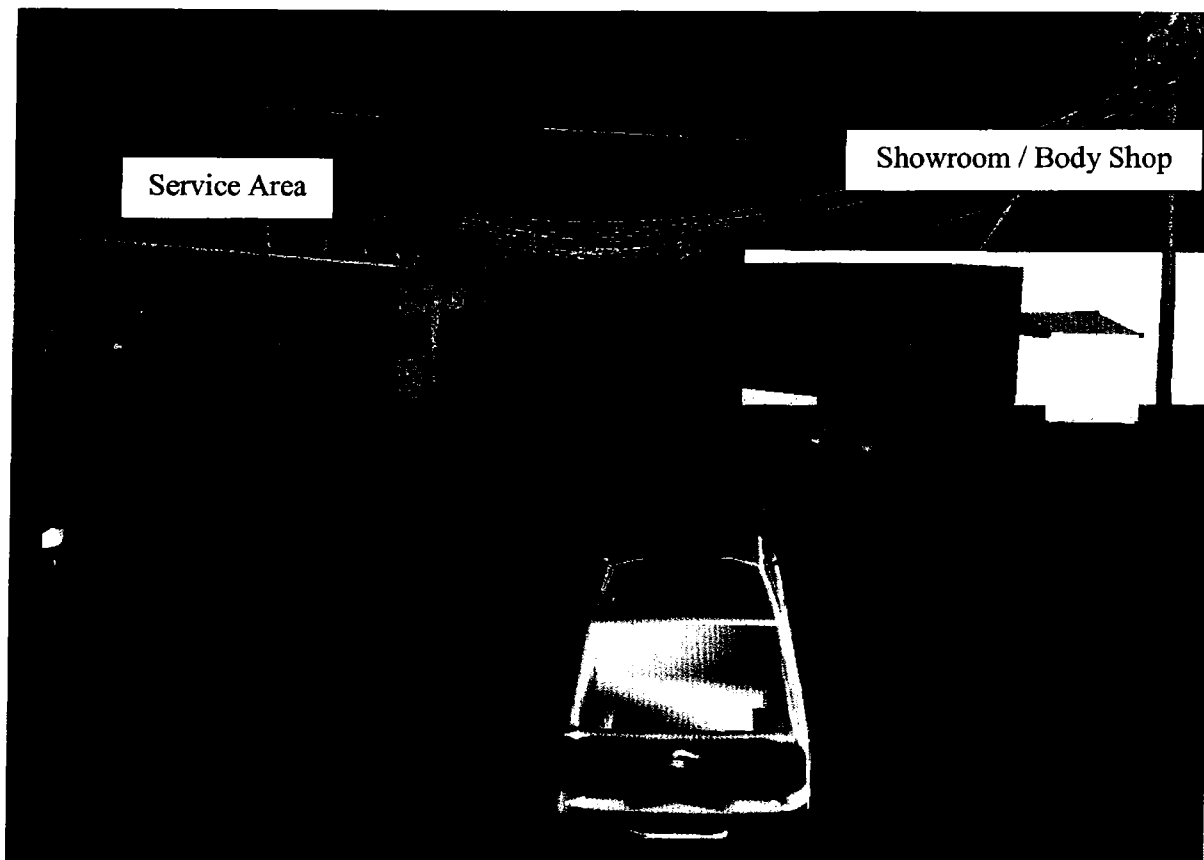
Figure 23

(An easterly view of the tractor/trailer from the rear parking lot, attempting to negotiate a turn into the alleyway.)

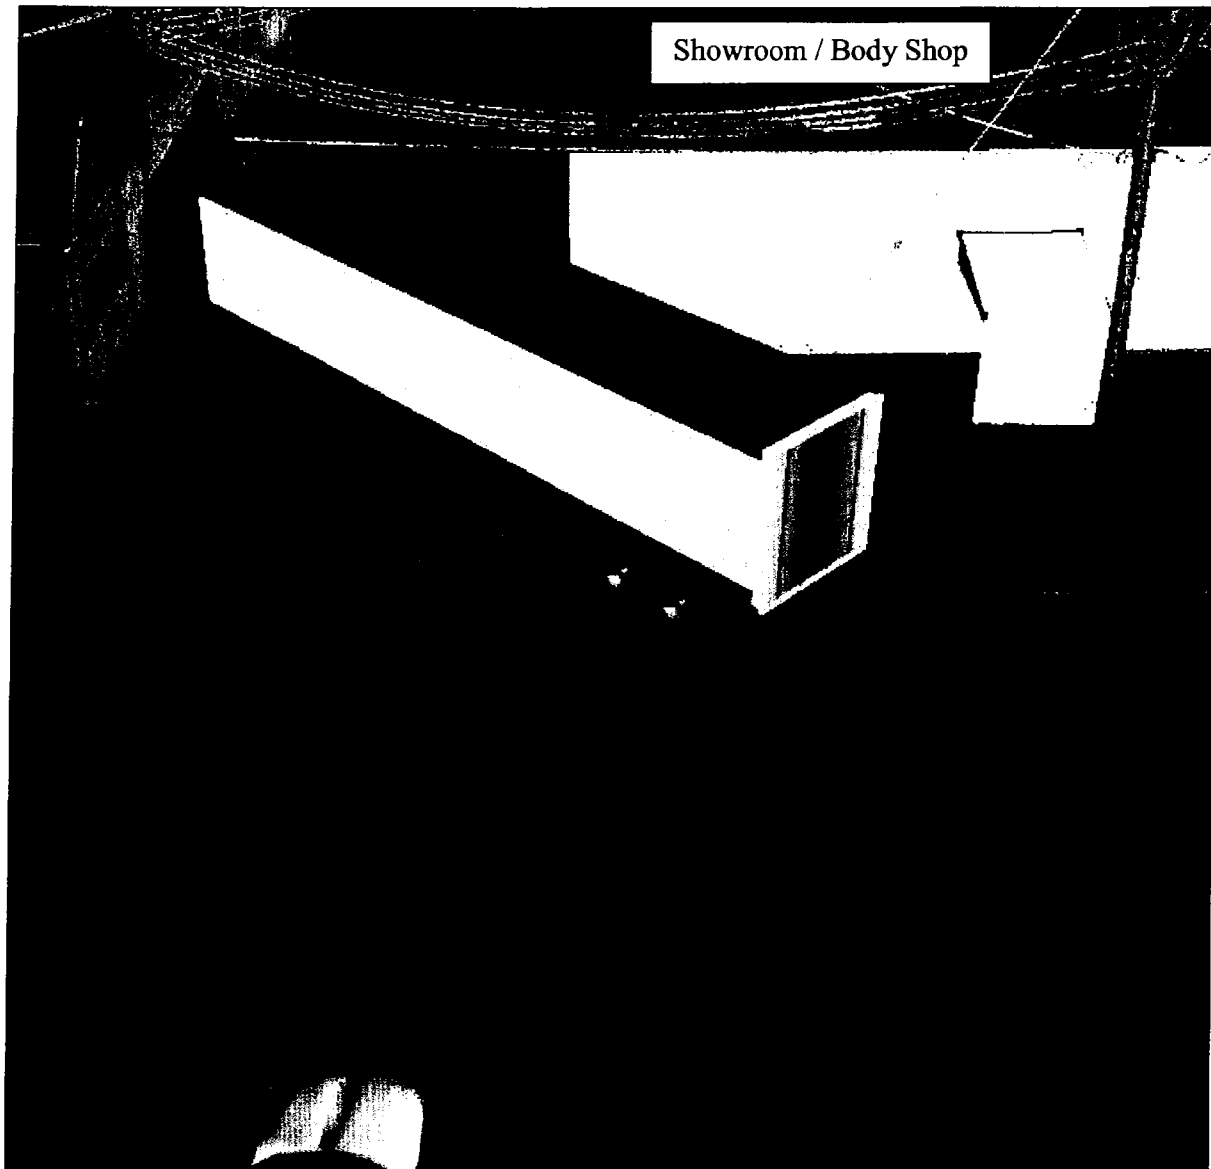
Figure 24

(Elevated view from the rear parking lot, facing east, of the tractor/trailer attempting to negotiate a turn into the alleyway).

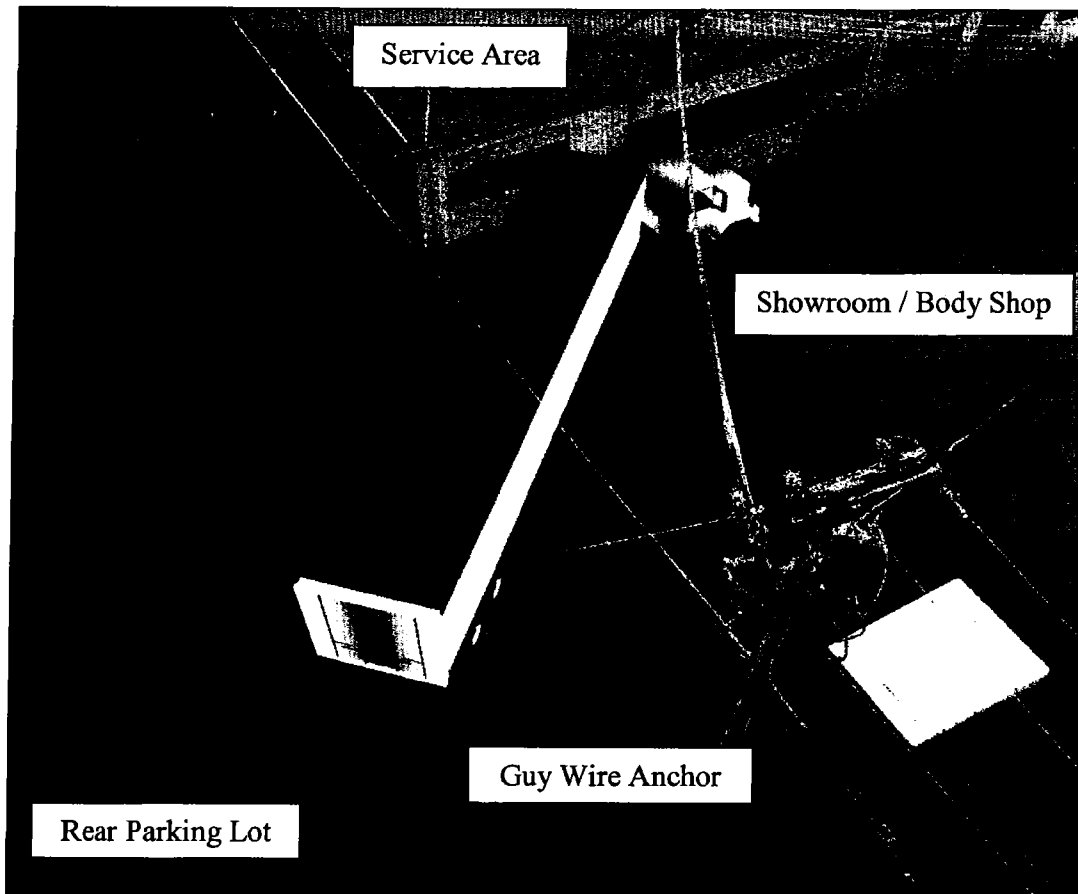
Figure 25

(Elevated view from the rear parking lot, northeast, of the tractor/trailer attempting to negotiate a turn into the alleyway striking the guy wire anchor.)

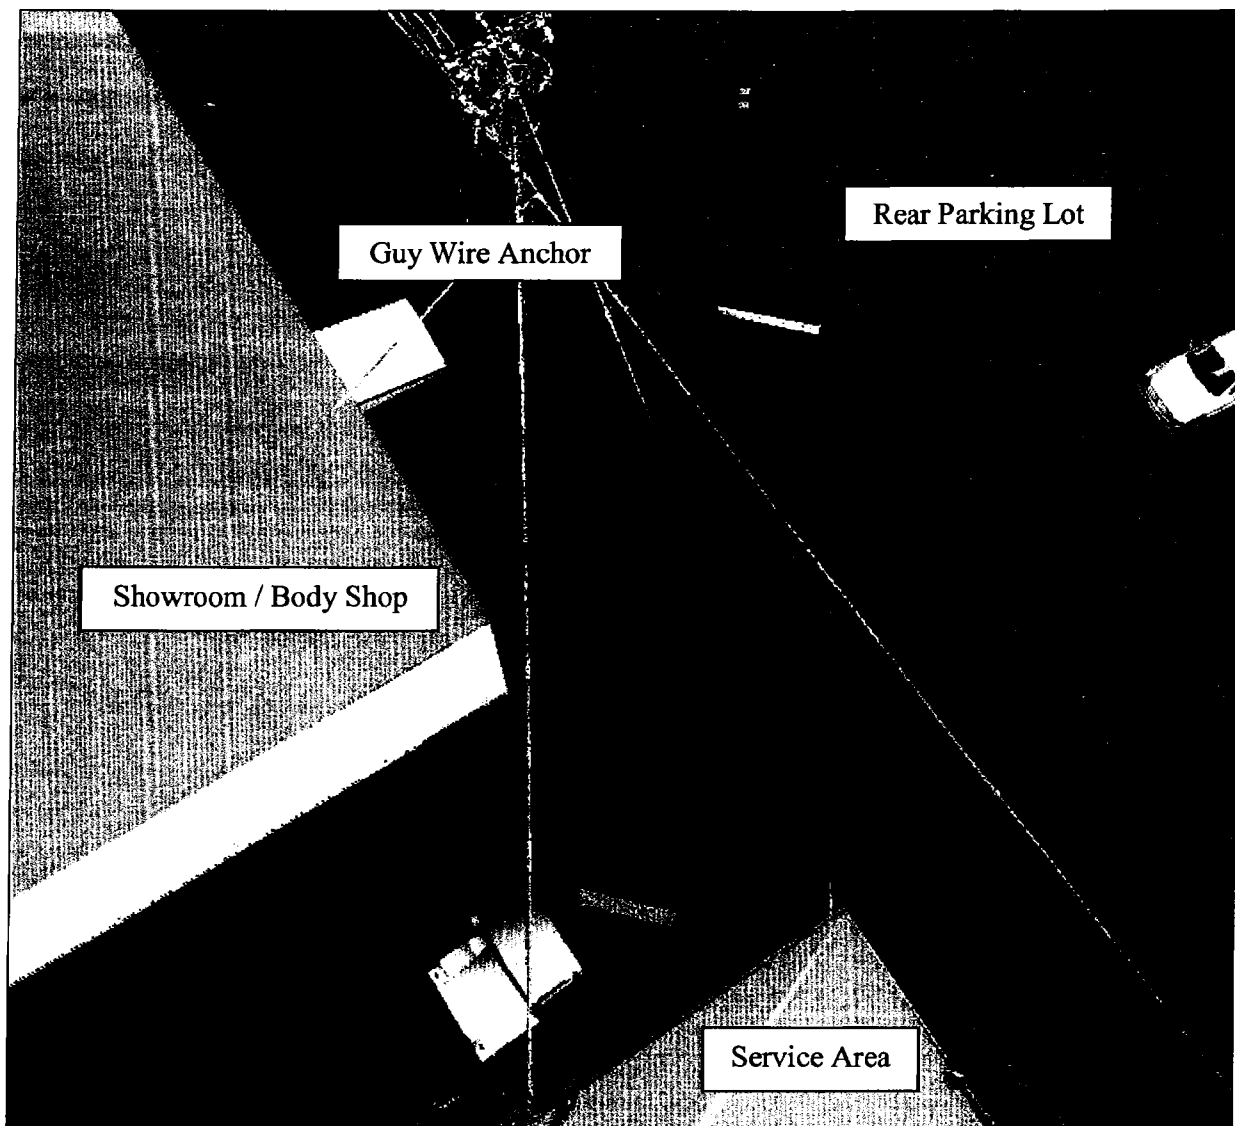
Figure 29

(Bird's eye view of third-axle-right facing southwest, striking the guy wire anchor.)

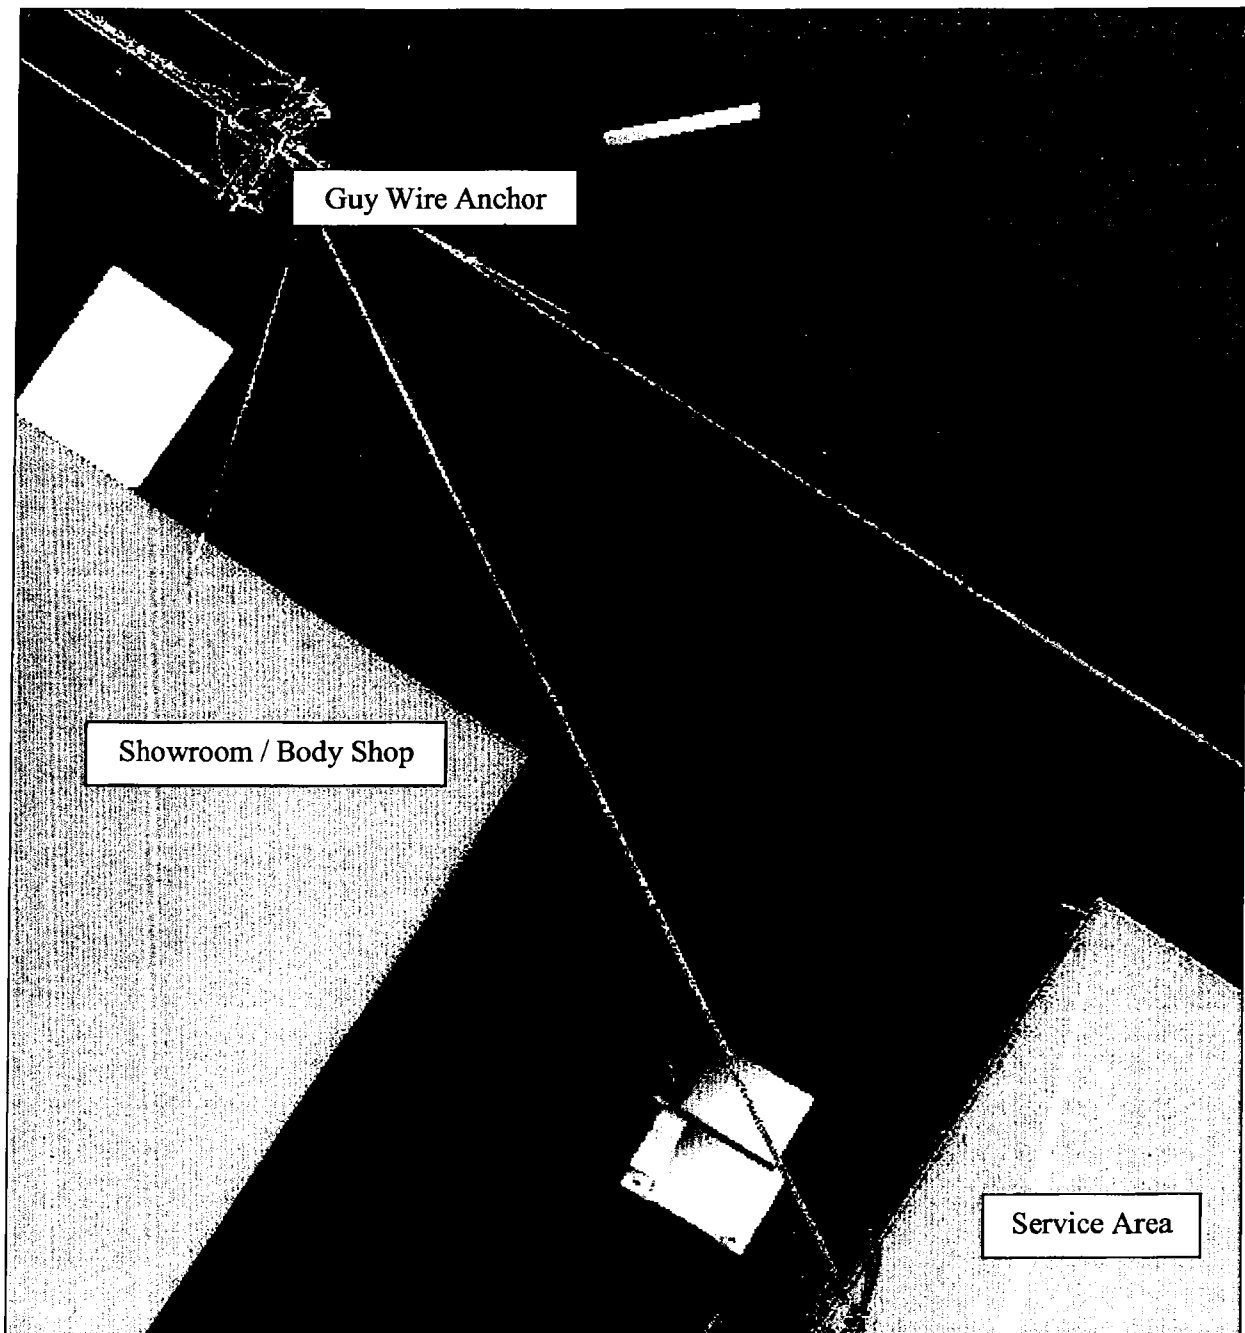
Figure 32

Bird's eye view of the tractor/trailer negotiating the right turn striking the guy wire anchor.)

This event was caused by the striking of the guy wire anchor positioning system by Mr. Harris' trailer tire while attempting to re-enter the alleyway between the showroom/body shop and the service buildings of the King's Chrysler dealership located at 3239 Wilmington Road in New Castle, PA on May 19, 2011. The striking of the anchor positioning system by Mr. Harris' third-axle-right trailer tire caused the guy wire to pull the top of the utility pole toward the showroom/body shop building. Subsequently, this contact also caused the bottom phase (power line) crossing the alleyway to lower, thereby allowing contact with the top right front of Mr. Harris' trailer as he continued in the alleyway. After the initial contact with the guy wire anchoring system, Mr. Harris continued driving forward, causing the guy wire attached to the top of the utility pole to pull forward toward the showroom/body shop building, eventually snapping the pole at its base and causing the resultant fire.
